Abutment fracture and the technique Used to Remove the fracture portion of the Abutmet: Case Report

Case Report

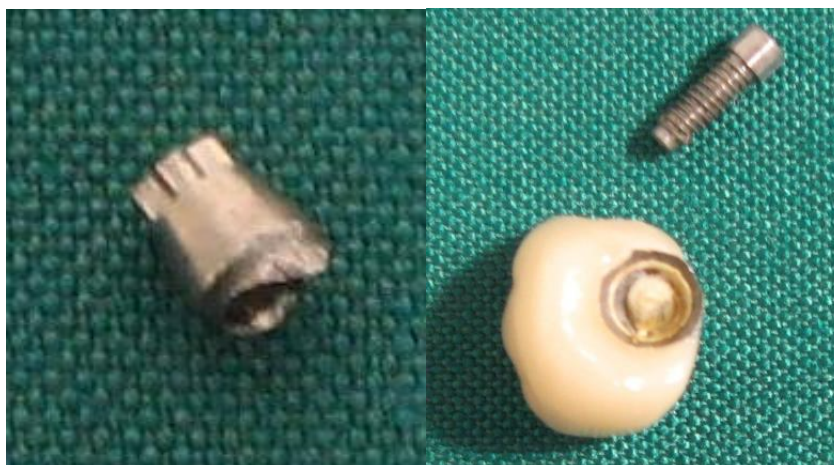
After 6 months, the patient returned with complaining of a loose crown on the implant. Clinical examination showed the remaining of one part of the abutment with the screw protective cotton within the crown (Figure 1). A periapical radiograph was taken, which showed that the base portion of the abutment had remained within the internal hex (Figure 2).

Figure 1. The fractured fragment of the abutment with the screw protective cotton within the crown

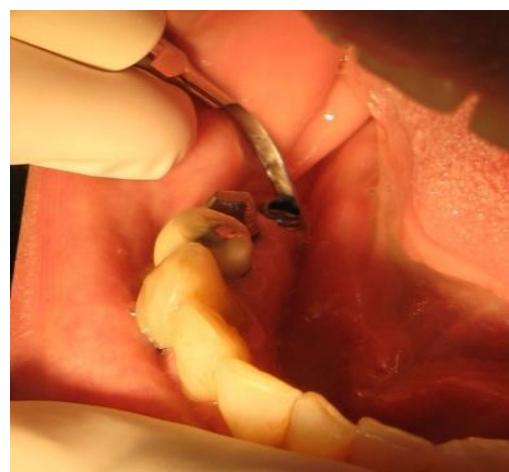
After removing the abutment screw, the base portion of the fractured abutment resisted to removing due to the close attachment and the presence of Morse taper. Despite attempts with a dental explorer and a periodontal curette, removal of the base portion of the abutment was not successful. Therefore, an ultrasonic tip was used counterclockwise to remove the base portion of the abutment (Figure 3). The fractured part of the abutment was removed without damaging the implant (Figure 4).

Figure 3. The ultrasonic tip (ccw)

To manage the presented case, an ultrasonic tip was applied counterclockwise (ccw) to remove the base portion of the fractured abutment which resulted in the fracture of the seal of the abutment, occurring due to the Morse taper, in order to remove the remaining part of the abutment. Studies on the removal of fractured abutments are limited. In one case, Roe used a modified crown-and-bridge remover for removing a fractured abutment (10).

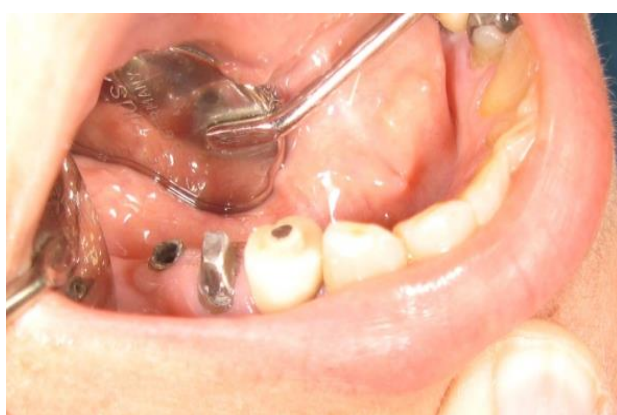
Figure 4. Removal of the base portion of the fracture abutment
