In Vitro Evaluation of Fracture Resistance of Zirconia Restorations Veneered by Two Different Systems: Rapid Layer Technique and Zir/CAD/CAM

Background: This study aimed to assess the fracture resistance of zirconia restorations fabricated with rapid layer (RL group) technique and zirconia computer-aided design/computer-aided manufacturing (zir/CAD/CAM) system (ZC group).

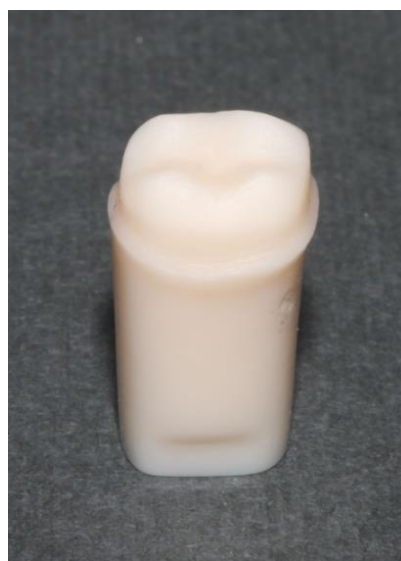
An anatomical resin mandibular right molar tooth fixed on a model of the mandible was used to fabricate the die (Figure 1). The resin tooth was prepared and underwent 2 mm of occlusal reduction. It also received a 360° chamfer finish line with 1.2 mm width.

Figure 1. Preparation of resin tooth

To control the magnitude of preparation, first, a silicon index (Panasil, Kettenbach GmbH., Germany) was obtained from the resin model. A mesiodistal section divided the index into buccal and lingual halves. The volume of preparation was frequently controlled using this index.

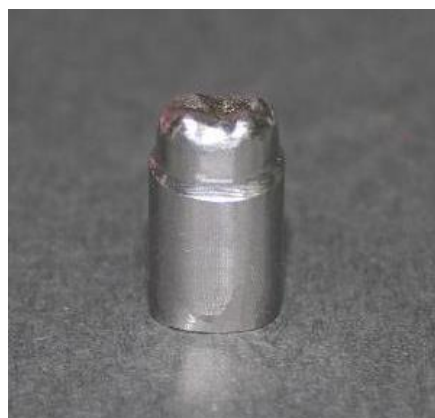
After preparation of the resin model, the prepared resin tooth was scanned by a laser scanner (3Shape D810; 3Shape, Denmark). The collected data were transferred to the respective device software (Sirona in Lab 2015, Sirona, Germany). The model was then processed in SolidWorks 2016 software (Dassault System solid works, Canada) and transferred to CNC machine (Maschinen-Wagner VMC 2040 - Maschinen-Wagner -Germany). Eventually, 30 metal dies were milled by the CNC machine using 316 steel alloy (UNS S31600 – AK Steel – USA) (Figure 2).

Figure 2. Steel die

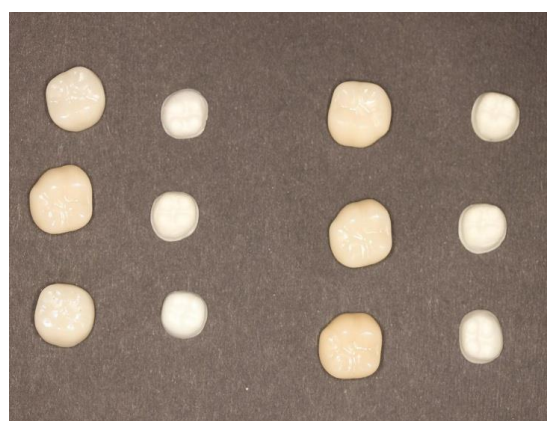
First, a metal die was scanned by the laser scanner and a full-contour anatomical form was designed by the software. Next, the device automatically divided this complete form into a framework with 0.5 mm thickness with the geometry of the milled model without undercut and a veneer with maximum thickness possible. The framework was first milled out of a zirconia block (Vita In-Ceram; Zahnfabrik, USA) and sintered in a furnace (VITA ZYRCOMAT 6000 MS; Zahnfabrik, USA) at high temperature (1540°C). Next, the veneering was milled using VITABLOCS TriLuxe forte blocks (Zahnfabrik, USA). After fabrication of the cores and veneers, each veneering was tried on its respective core and its adaptation was evaluated. Also, the adaptation of zirconia cores on metal dies was evaluated (Figure 3).

Figure 3. Cores and veneers milled by the rapid layer system

Finally, the fabricated veneer was cemented on the fabricated framework using Panavia F2 (Kuraray, Japan) resin cement as follows: The internal surface of the veneering and the external surface of the cores were sandblasted with 50 μ alumina particles at a pressure of 2 bar (Basic mobil – Renfert – Germany). Next, the internal surface of the veneers was etched with 9% hydrofluoric acid (Ultradent, Germany) for 60 seconds. After rinsing with water, they were immersed in ethanol 100% (Wilmar, Australia) for 5 minutes and placed on a vibrator. After that, they were rinsed with water again and air was sprayed for 20 seconds.

ED primer (Kuraray, Japan) was mixed according to the manufacturer's instructions and applied on the external surface of the veneering by a micro brush. Equal amounts of the two pastes of Panavia F2 were mixed on a glass slab and applied on the entire internal surface of the veneer. The core was then placed inside the veneer and compressed in order for the excess cement to leak out. After obtaining a primary fit prior to cementation, excess cement was removed by the sharp tip of an explorer and the samples were light-cured for 20 seconds.

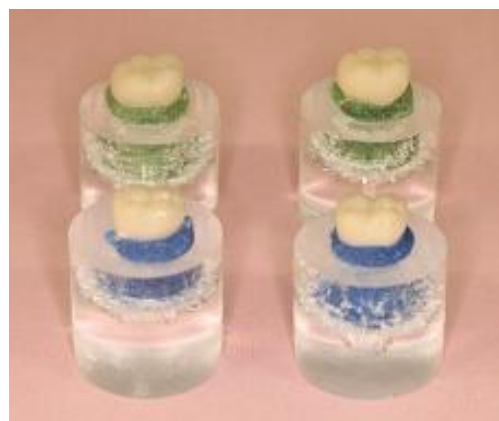
The entire cementation process was performed by one operator. Glass ionomer cement was mixed with a plastic spatula for 20 seconds and spread on the internal crown surface using a disposable applicator. The crowns were placed over the dies and held in place by uniform finger pressure for 10 minutes. The assembly of the crown and metal die was stored in water at 37°C for 48 hours. Prior to load application, the samples were thermocycled for 1000 cycles between 5-55°C (TPO, Nemo, Iran). To stabilize the samples for fracture resistance testing, metal dies along with their restorations were mounted in polyethylene cylindrical rods based on their color (Figure 4) (12,21).

Figure 4. Fixing metal dies over cylindrical rods

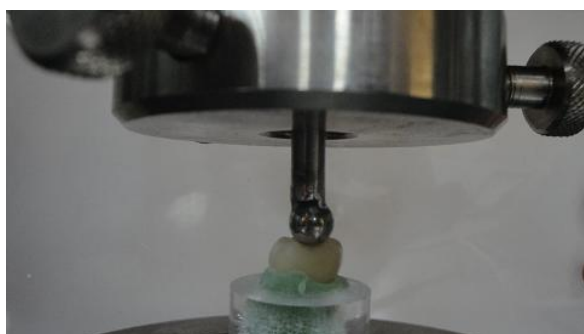
Fracture resistance was measured using a universal testing machine (Z100/Z250; Zwick Roell, Ulm, Germany) (Figure 5).

A cylindrical rod with 6 mm diameter was used to obtain a three-point contact on the occlusal surface of restoration for load application until restoration fracture. The load was applied at a crosshead speed of 0.5 mm/minute. The load at failure was recorded as the fracture load. The mode of fracture was also determined visually and recorded.

Figure 5. Load application to samples

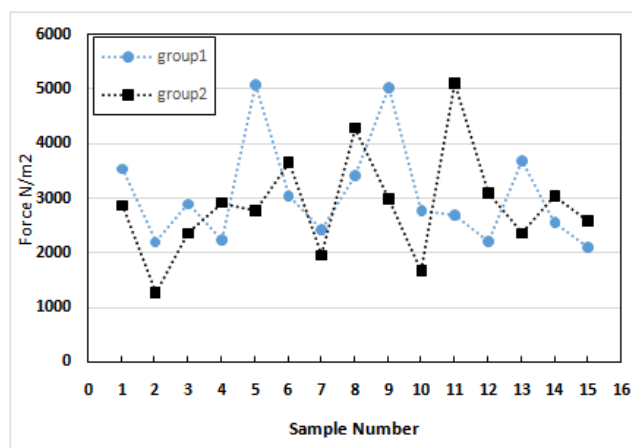
Independent t-test showed that although the mean fracture resistance in group 1 was higher by 187 units compared to

group 2, this difference was not statistically significant (Table 1). Diagram 1 depicts the distribution of the fracture load.

Diagram 1. Fracture load in RL and ZC groups

Group	Mean	Standard deviation	P-value
ZC	3056.3033	955.91335	0.599
RL	2869.4487	967.53476	0.599

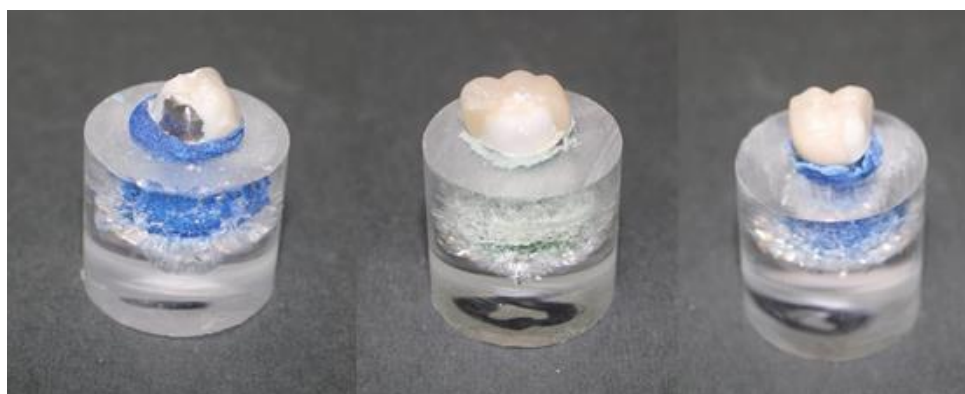
Mode of fracture was partial and occurred only in the veneering in all samples of the RL group. In ZL group, however, the fracture was partial in 13 samples (a thin layer of the veneering remained on the zirconia surface). Total fracture of the core and veneering was noted in two samples in this group. Fracture in RL group was in the form of the breaking of the veneering (Figure 6).

Figure 6. Fracture modes of all-ceramic restorations. From right to left: fracture in ZC sample, fracture in RL sample, total fracture in ZC sample

The results showed that the mode of failure in RL samples was adhesive. In other words, fracture of the veneering occurred at the adhesive interface and the veneering layer broke. However, in ZC samples, the mode of fracture was cohesive within the veneering layer, which indicated higher susceptibility of the samples fabricated by the RL system to unfavorable fractures.

breakage of the veneering was observed. This indicated poor bonding of the core-veneering (1,22). The majority of samples in ZC group showed cohesive fracture within the veneering in the form of porcelain chipping in only one point of the restoration. This form of fracture in zir/CAD systems allows restoration repair. In the RL group, adhesive fracture occurred in the cement layer in the form of breakage of the veneering which led to the separation of the veneering from the core. In RL samples, the veneering broke into pieces and was separated from the core which made the restoration repair impossible. This type of fracture in RL samples is due to the low bond strength of resin cement to zirconia core which has also been mentioned by Baltz et al. (23). Also, some other studies have evaluated the strategies to increase the bond strength of resin to zirconia (24,25).
